Extreme Testing of Guard Cables with Fiber Optics: A Case Study

Context: Optical fiber ground wires (OPGWs) sometimes melt and rupture when exposed to extreme conditions, such as atmospheric discharges, short circuits, and corrosive agents, that affect their electrical and mechanical properties. These conditions depend on the geographical area where the cable is installed, with the most critical being industrial and coastal zones as well as marine and mountainous environments. This research analyzes a cable rupture due to lightning strikes from a coastal zone.

A sample of failed OPGWs was acquired from a transmission line located in the coastal area of Valladolid, Yucatán, Mexico (DZT-A360-RXXY-LT 400 kV line). The samples were divided into sections, A and B, whose properties and conditions after cable failure were analyzed. The failure zone was also studied. The tests carried out were visual and dimensional inspection and mechanical stress and chemical tests. Some lightning strike points were preliminarily marked as the main causes of OPGW breakage.

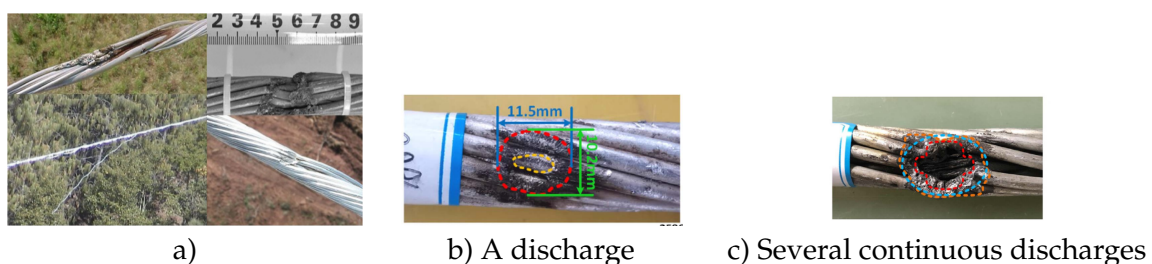
Figure 2. a) OPGW cable affected by an atmospheric discharge (Federal Electricity Commission) and guard cable with CFE optical fibers E1000-21. b) and c) Experimental results of controlled electrical discharges in the laboratory (11)

Fig. 2 shows the conditions potentially generated by atmospheric discharge in the cable, which involve high energy in short periods of time, or *vice versa*. It has been determined that the first case is associated with atmospheric discharges and the second with short-circuit conditions. The authors of (11) suggested that the damage increases linearly with the increase in charge transfer. As the discharge area increases, the intensity of the arc charge decreases. However, the volume of damage undergoes a non-monotonous change, which is due to complex variations in the area of attachment of the arc, regulated by the discharge space and the intensity of the current.
