## Extreme Testing of Guard Cables with Fiber Optics: A Case Study

Erick-Alejandro González-Barbosa<sup>1</sup>, Fernando Jurado-Pérez<sup>1</sup>, José-Joel González-Barbosa<sup>2</sup>, and Julio César Méndez Gutierrez<sup>1</sup>

> <sup>1</sup>Tecnológico Nacional de México/ITS de Irapuato, México <sup>2</sup>Instituto Politécnico Nacional, CICATA-Queréretaro, México

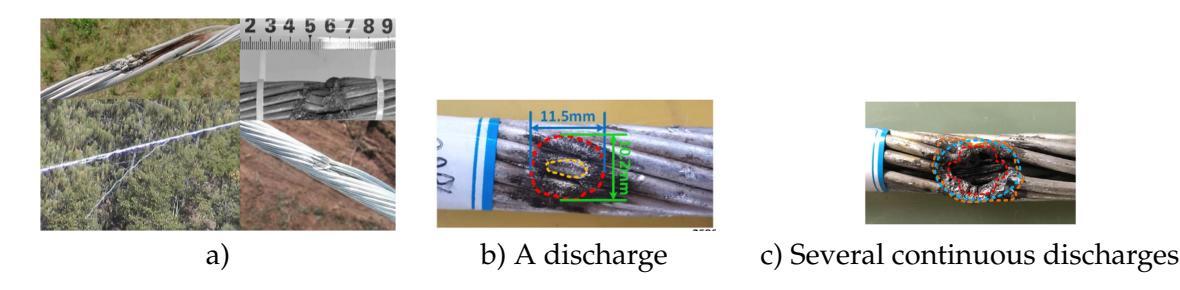
**Figure 2.** a) OPGW cable affected by an atmospheric discharge (Federal Electricity Commission) and guard cable with CFE optical fibers E1000-21. b) and c) Experimental results of controlled electrical discharges in the laboratory (11)

Fig. **2** shows the conditions potentially generated by atmospheric discharge in the cable, which involve high energy in short periods of time, or *vice versa*. It has been determined that the first case is associated with atmospheric discharges and the second with short-circuit conditions. The authors of (11) suggested that the damage increases linearly with the increase in charge transfer. As the discharge area increases, the intensity of the arc charge decreases. However, the volume of damage undergoes a non-monotonous change, which is due to complex variations in the area of attachment of the arc, regulated by the discharge space and the intensity of the current.

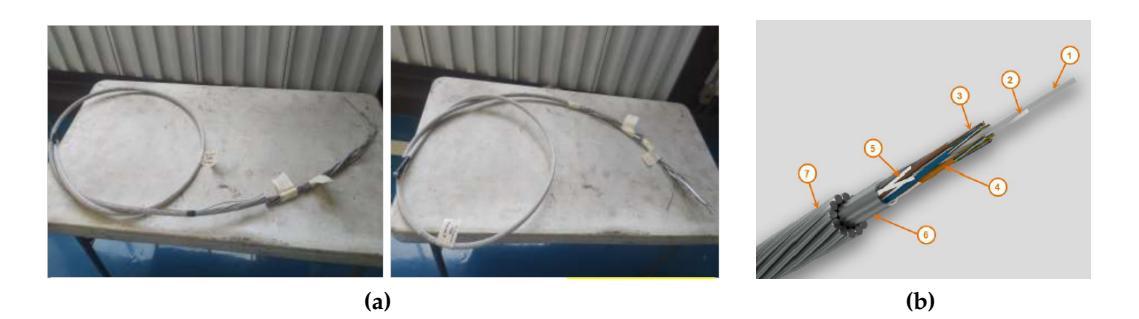
The analysis presented herein is based on 12 aluminum alloy wires surrounding the core of an OPGW cable, an element indicated as (7) in Fig. 3b. These aluminum alloy wires are made of 1350 aluminum-coated steel and support the OPGW's cable structure. The samples were tested according to regulations and were 0.30 m long. The failed OPGW was a 36-fiber cable with a diameter of 16 mm and an energy transfer capacity of 50 Coulomb (C). Details are shown in Fig. 3b.

**Figure 3.** 36-wire OPGW. (a) Analyzed samples, sections A and B. (b) Guard cable with OPGW optical fibers, 36 single-mode fibers of class 0 for atmospheric discharge, category A for thermal dissipation. (1) Dielectric central element. (2) Thread to block water penetration. (3) Single-mode optical fibers. (4) Three thermoplastic tubes filled against water, each with 12 fibers. (5) Threads for blocking water penetration. (6) Aluminum tube. (7) 12 aluminum-coated steel wires,  $\emptyset$ =2.92 mm

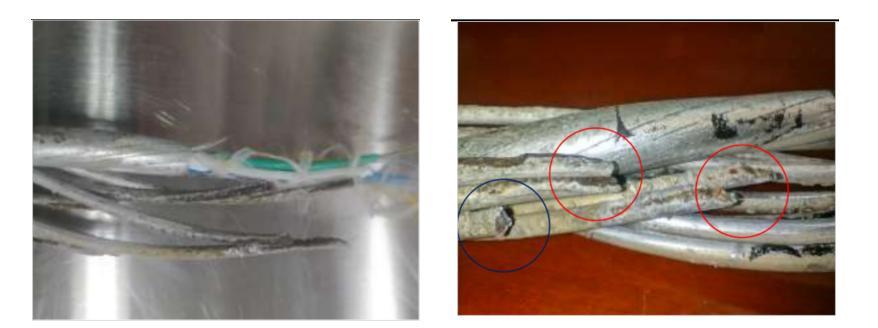
Section A comprises steel wires clad with aluminum, with deposits of corrosive agents exhibiting whitish and brown colorations due to the oxidation of the localized base material. In addition to the loss of material on the wire surface, the OPGW's 12 crown wires show melting of the material and loss of coating from the point of failure up to distances of 0.40 m. A visual inspection was carried out before cutting the 0.30 m sections for the tension test. The ends of the wires showed a reduced cross-section in the failure zone, and 11 out of the 12 wires had sharp tips due to the loss of material and the type of failure. Moreover, the aluminum tube where the optical fibers were located exhibited a transverse reduction in the affected area. Fig. 4 shows the steel wires with aluminum coating in the crown, which exhibit wear and melting of the base material as well as sharp points. For section A, the aluminum tube containing the fibers showed a reduced diameter in the affected area - the reader should recall that this section includes three filaments with 12 optical fibers each (Figs. 5c and 5d). As observed in a close-up of the OPGW, there are fractures in some of the wires in the fault zones, mostly ductile faults and smelting due to atmospheric discharge, in addition to wires and material detachment in the fault zone, with some elements of oxidation and coating loss (Figs. 5a and 5b). Oxidation is observed in Figs. 5a, 5b, and 5c, as well as pitting of the coating and loss of material. Fig. 5d shows the failed core tubing, which contains the optical fibers, in addition to a reduced cross-section due to mechanical stress. In the failed OPGW, clear signs of warming, short circuits, and cross-section reduction are also observed.

Section B of the failed sample indicates the loss of the aluminum-coated crown, which may be due to material melting. The tips of the wires have a reduced cross-section in the failure zone, and 10 of them have sharp points. One of the wires does not exhibit loss of area in it is cross-section due to brittle fault, and one more suggests a tool cut.

**Figure 4.** Left: failed section; right: fracture and material melting zone. Marked in red, sharp points can be observed

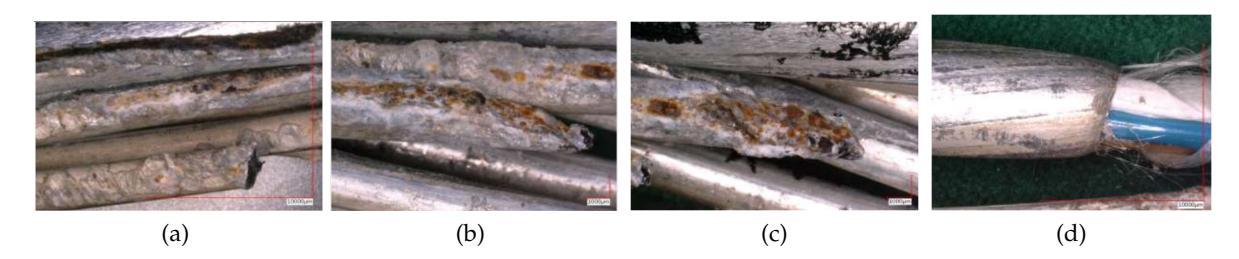
**Figure 5.** Affected area of the wires: a) oxidation and loss of material, b) loss of aluminum coating, c) oxidation and pitting of the coating as well as material loss, d) core tubing failure due to mechanical stress

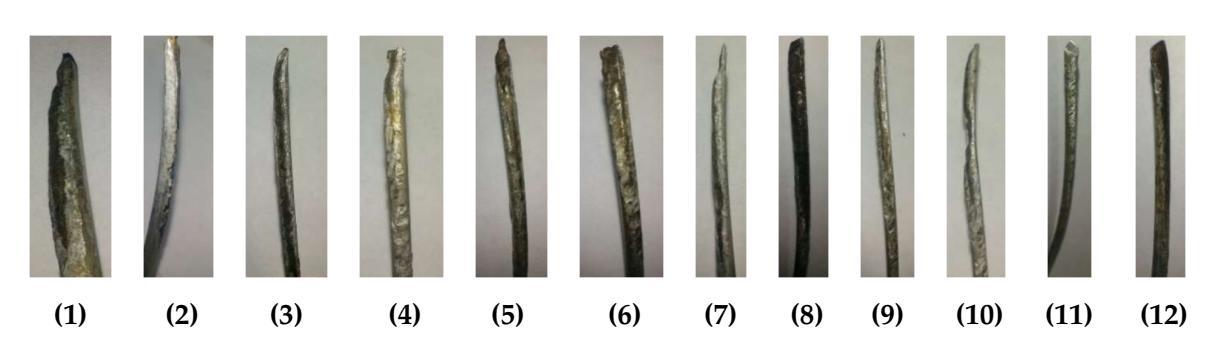
Fig. 6 shows the 12 failed OPGW wires. The visual analysis of each wire is summarized below:

- Wire 1 has a reduced cross-section as well as a fragile fracture footprint.
- Wire 2 has a reduced cross-section and whitish deposits.
- Wire 3 has a material release on the tip, and a lack of aluminum coating can be observed.

- Wire 4 exhibits a fragile fracture pattern and temperature-induced material melting.
- Wire 5 has a reduced cross-section and an almost completely melted tip.

- Wire 6 exhibits a reduced cross-sectional area and fragile fault; coating loss is observed.
- Wire 7 shows a reduced cross-section, and the tip shows signs of brittle failure. Signs of aluminum coating loss and temperature melting are also observed.

- Wire 10 shows a reduced cross-section area and a sharp tip. The observed material loss corresponds to more than 50% of its section. There is also a lack of coating, and even the loss of much of the base material.

Figure 6. Failed OPGW crown wires, section B

- Wire 11 exhibits signs of tool cutting.
- Wire 12 shows a minimal reduction of its cross-section area and fragile footprint, with minor deformation, but it shows signs of material detachment caused by high temperatures.

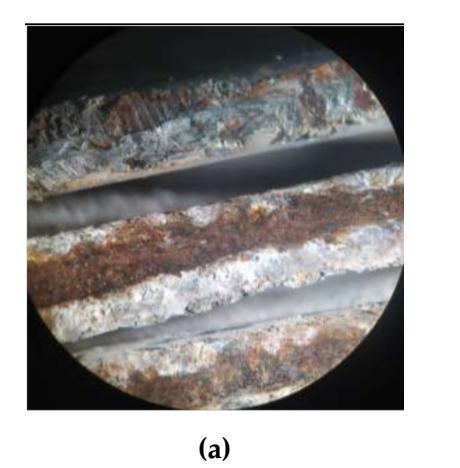
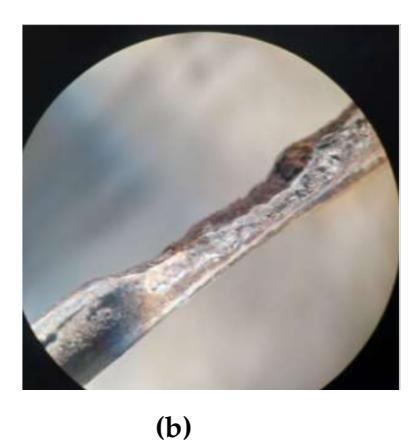
Corrosion zones were identified in the steel wires coated with aluminum, as well as embedded deposits of elements unrelated to the composition of the material. We also observed the melting and loss of material in the fault zone due to atmospheric discharge. Figs. 7a, 7b, and 14 show the close-up and microscopic inspection of the OPGW's critical zones.

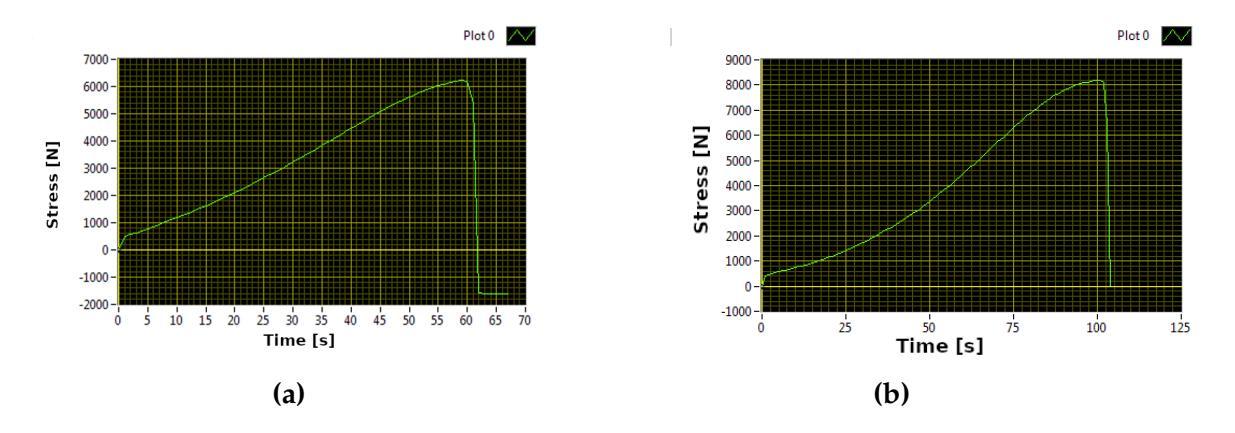
Figure 10. Point load vs. time graph for a) wire 1 and b) wire 11 of section A

The time until failure in most of the wires of sections A and B is close to 120 or 140 *s*, with some exceptions, such as wire 1 of section A, which failed within 60 *s* of applying the load according to the established parameters and execution speed. In both sections, a ductile and homogeneous failure behavior was observed, validating the quality of the analyzed cable.

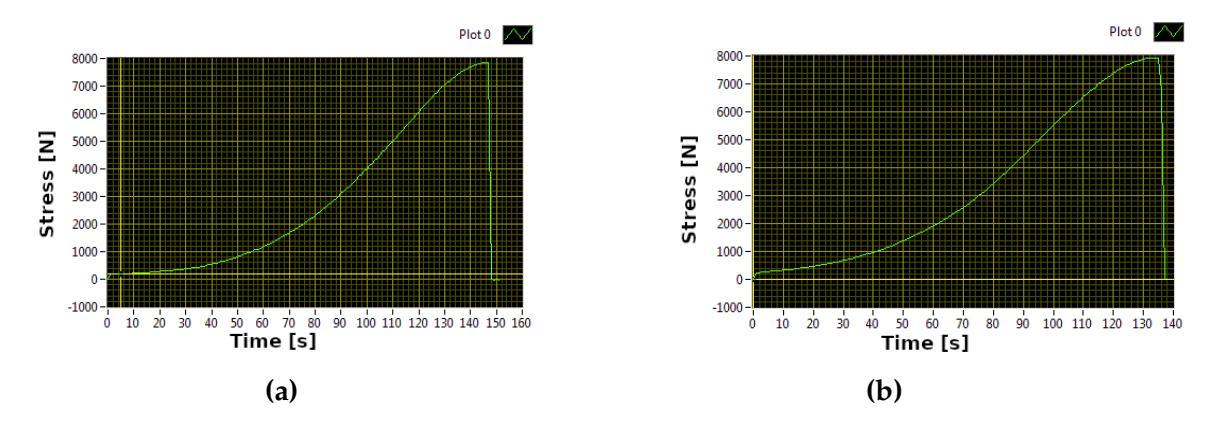
Figure 11. Point load *vs.* time graph for a) wire 1 and b) wire 11 of section B.

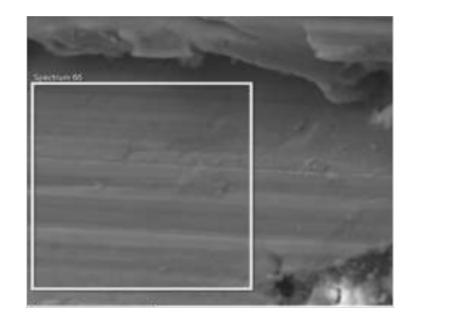
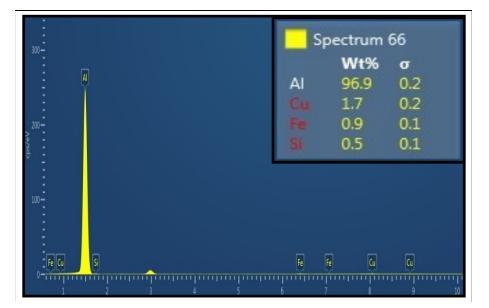
Figure 13. Elemental chemical analysis of the crown that makes up the OPGW

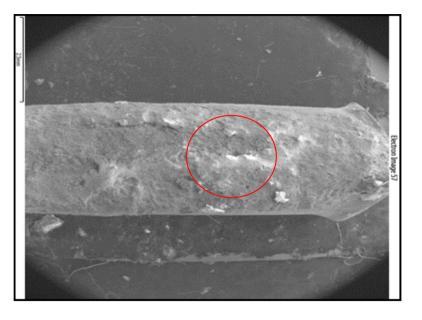
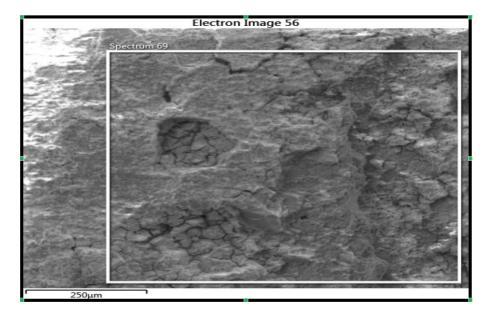
In the images of Fig. 14, a wire of the OPGW is seen to be visibly affected, with signs of pitting and a reduced cross-section. With prior verification through visual, dimensional, and microscopic inspection, a few bites were analyzed, corroborating the presence of corrosive agents, in addition to quantifying the loss of base material.

**Figure 14.** Zoom-in of the red zone of a visibly affected wire, with signs of pitting and corrosion. The chemical analysis of this zone is shown in Fig. **15**

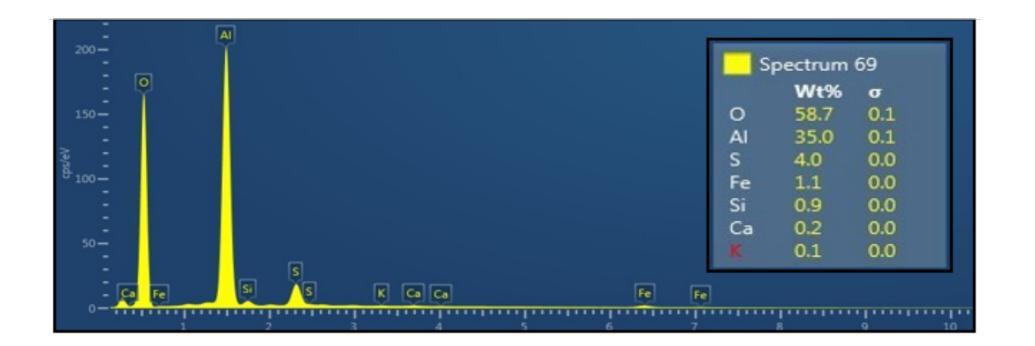
The chemical analysis of the pitting area defined as *Spectrum 69* can be observed in Fig. **15**. The results indicate a high concentration of oxide due to the amount of oxygen recorded (58.7%), which suggests an accelerated process regarding the natural oxidation of the base material (Fe), observed in the form of a reddish-brown coloration. In this case, natural oxidation was mostly generated by humidity

and environmental conditions. The deposits attached to the wire's aluminum contained highly corrosive elements concentrated in the pitting area, such as sulfur (S), *i.e.*, up to 4 %, which is a large amount of corrosive agent. The percentage of coating on the wire, which should remain above 90 % (Al), was 35 %, indicating losses. Therefore, the health of the element's coating was affected by the operating conditions. The guard wire with optical fibers exhibited reduced electrical properties and mechanics in this area.

The deposits adhered to the wires were also identified. The aluminum coating contained corrosive elements such as S and Na in the zone of base material loss, and we observed the loss of the covering layer and a significant percentage of oxygen due to the oxidation process caused by environmental and industrial impacts. The agents usually come from industrial areas and combine with oxygen and moisture in the environment, leading to the formation of acids and hydroxides that act as corrosive agents and accelerate the degradation of the material. These corrosive agents act mainly on the galvanized steel wires that make up the core of the cable, aggressively deteriorating their Zn layer, penetrating into the base material. With the above, a material loss process takes place, decreasing the wire's diameter and inducing a stress concentration on the driver element. The area decrease generates a temperature increase in the wires, as current is conducted through a smaller cross-section. Under these conditions, wires subjected to combined electromechanical and thermal stress can gradually yield, resulting in rupture.

Figure 15. Elemental chemical analysis of pitting in the OPGWs
