## Extreme Testing of Guard Cables with Fiber Optics: A Case Study

Erick-Alejandro González-Barbosa<sup>1</sup>, Fernando Jurado-Pérez<sup>1</sup>, José-Joel González-Barbosa<sup>2</sup>, and Julio César Méndez Gutierrez<sup>1</sup>

> <sup>1</sup>Tecnológico Nacional de México/ITS de Irapuato, México <sup>2</sup>Instituto Politécnico Nacional, CICATA-Queréretaro, México

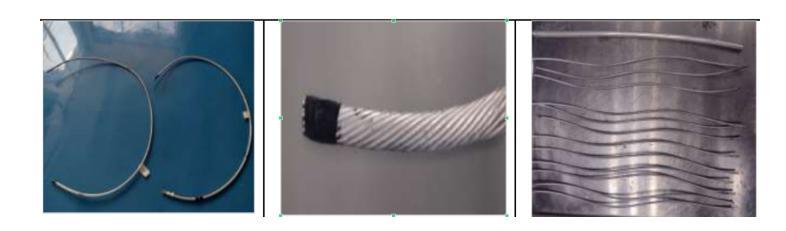
Fig. 8 shows two cable sections (class 0, 0.30 *m* in length, as stipulated by the E1000\_21 specification for stress testing). The elastic modulus (E) of the analyzed cable is around 116 Gpa. Table II analyzes the

**Figure 8.** 0.30 *m* long OPGW cable for tension tests, aluminum tube containing the optical fibers and their 12 test wires

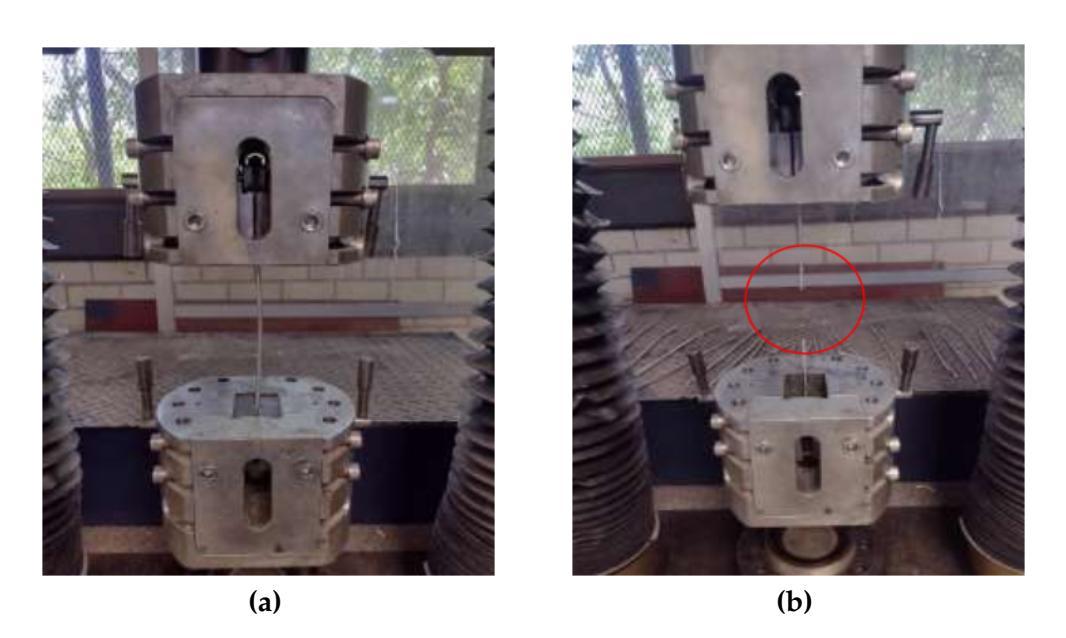
The test sequence was carried out using the JAUS universal machine (Fig. 9), applying a constant load at a speed of 5000 N/min. Test runs were performed for each of the wires from sections A and B. Fig. 9b shows one of the OPGW cable wires, which fails upon reaching the limit of its mechanical resistance to tension. The 30 ton JAUS vertical machine was located in a mechanical testing lab, and it had been calibrated by the laboratory of metrology.

**Figure 9.** OPGW cable wire tension test: a) universal tension machine at the start of the test; b) end of test upon failure

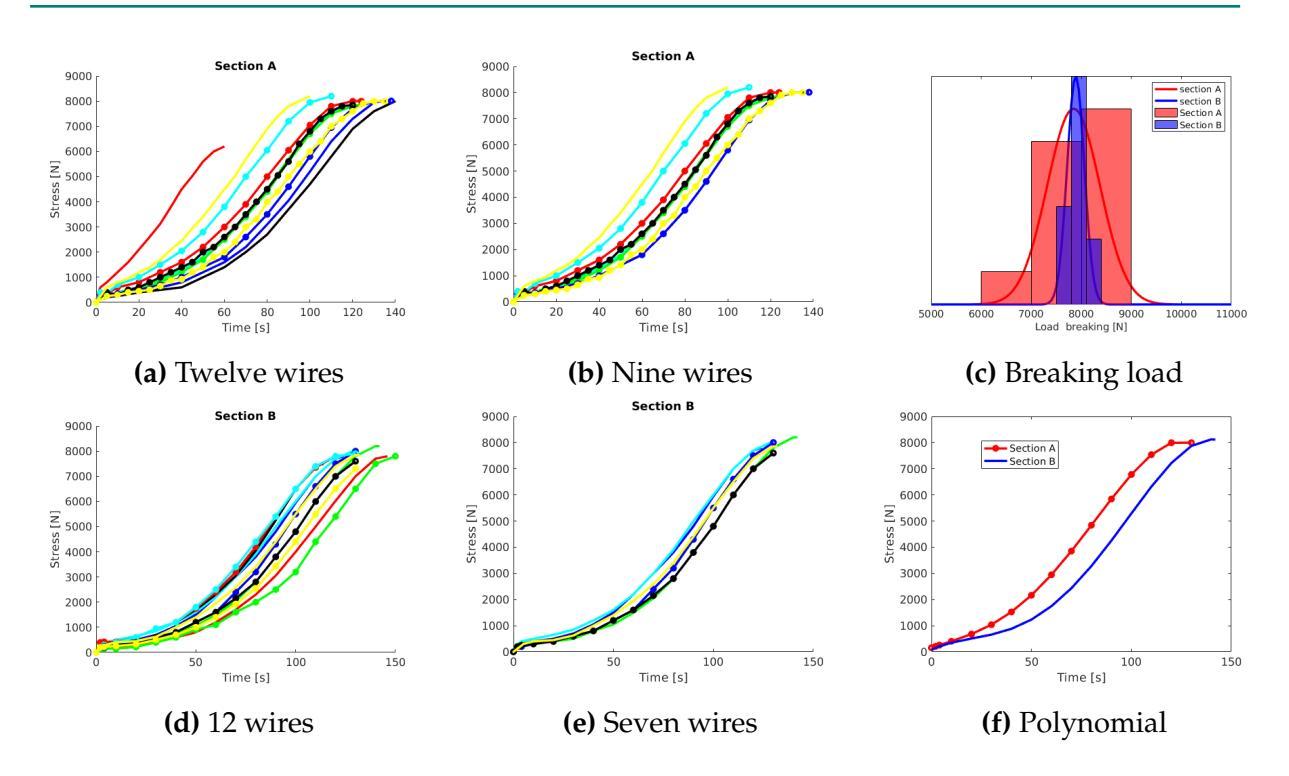
Eqs. (1) and (2) represent the polynomial approximation of stress *vs*. time for sections A and B, respectively. For these equations, we considered the curves shown in Figs. 12b and 12e, which correspond to the *SetRepresentative* variable in Algorithm 1. Fig. 12f shows the polynomial approximation of Eqs. (1) and (2). The behavior of the cables exposed to discharges changes considerably, while those with little exposure maintain a similar behavior.

**Figure 12.** Stress *vs.* time graph. (a) and (d) show the 12 wires of section A and B. (b) and (e) were generated by removing the curvy cables at the top and bottom of the graph. (c) corresponds to the breakdown load distribution in section A and B wires, and (f) represents the polynomial approximation using the curves (b) and (e)
