Extreme Testing of Guard Cables with Fiber Optics: A Case Study

Context: Optical fiber ground wires (OPGWs) sometimes melt and rupture when exposed to extreme conditions, such as atmospheric discharges, short circuits, and corrosive agents, that affect their electrical and mechanical properties. These conditions depend on the geographical area where the cable is installed, with the most critical being industrial and coastal zones as well as marine and mountainous environments. This research analyzes a cable rupture due to lightning strikes from a coastal zone.

A sample of failed OPGWs was acquired from a transmission line located in the coastal area of Valladolid, Yucatán, Mexico (DZT-A360-RXXY-LT 400 kV line). The samples were divided into sections, A and B, whose properties and conditions after cable failure were analyzed. The failure zone was also studied. The tests carried out were visual and dimensional inspection and mechanical stress and chemical tests. Some lightning strike points were preliminarily marked as the main causes of OPGW breakage.

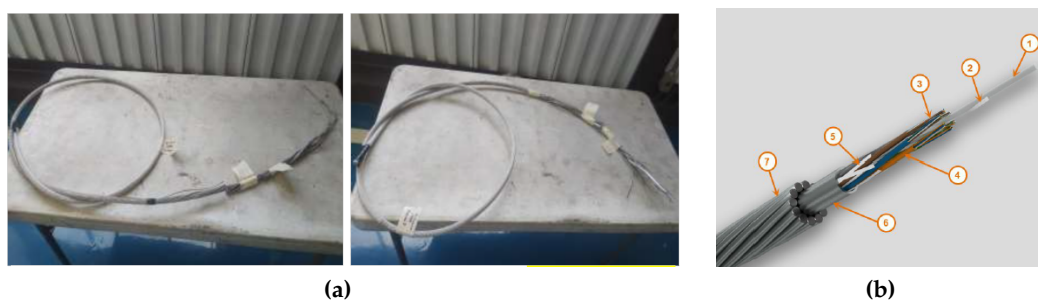
The proposed methodology also makes it possible to accurately assess the effects on the failed cable both at the location of the fault and close to it. The tests involved allow determining the causes of the damage and proposing precautionary measures. The case study includes a sample of a guard cable with an integrated fiber optic wire subdivided into two sections after the failure (Fig. 3a). Both sections are linked to failure by cable fraying, as observed in the fractured wires.

The analysis presented herein is based on 12 aluminum alloy wires surrounding the core of an OPGW cable, an element indicated as (7) in Fig. 3b. These aluminum alloy wires are made of 1350 aluminum-coated steel and support the OPGW's cable structure. The samples were tested according to regulations and were 0.30 m long. The failed OPGW was a 36-fiber cable with a diameter of 16 mm and an energy transfer capacity of 50 Coulomb (C). Details are shown in Fig. 3b.

Figure 3. 36-wire OPGW. (a) Analyzed samples, sections A and B. (b) Guard cable with OPGW optical fibers, 36 single-mode fibers of class 0 for atmospheric discharge, category A for thermal dissipation. (1) Dielectric central element. (2) Thread to block water penetration. (3) Single-mode optical fibers. (4) Three thermoplastic tubes filled against water, each with 12 fibers. (5) Threads for blocking water penetration. (6) Aluminum tube. (7) 12 aluminum-coated steel wires, $\varnothing=2.92$ mm

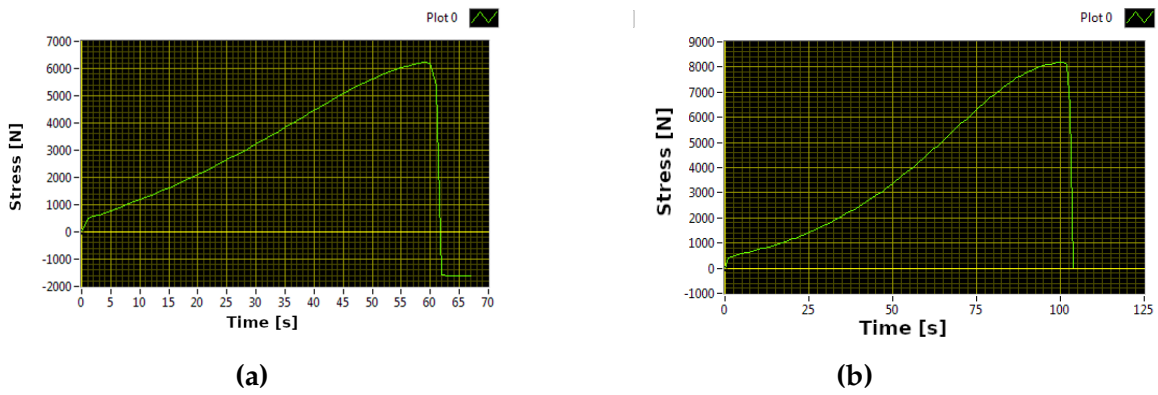
Test runs were performed for each of the wires that make up sections A and B. The mechanical stress results show the behavior of some of the outer wires in the OPGW cable crown upon applying a point load at a given time. Fig. 10 shows the load vs. time graph for cables 1 and 11 of section A. The graph for section B is presented in Fig. 11. These rupture values can be verified in Table II.

Figure 10. Point load vs. time graph for a) wire 1 and b) wire 11 of section A

The time until failure in most of the wires of sections A and B is close to 120 or 140 s, with some exceptions, such as wire 1 of section A, which failed within 60 s of applying the load according to the established parameters and execution speed. In both sections, a ductile and homogeneous failure behavior was observed, validating the quality of the analyzed cable.

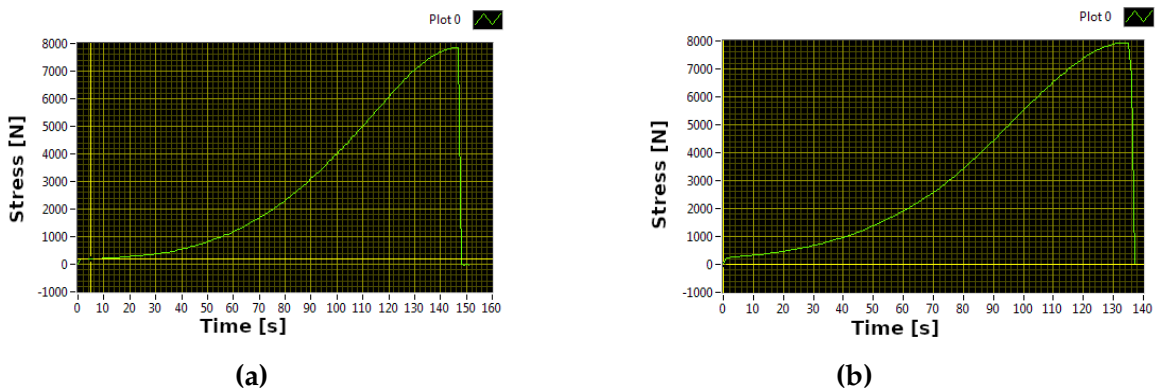
Figure 11. Point load vs. time graph for a) wire 1 and b) wire 11 of section B.
